Assessment of Recent Aircraft Lightning Accidents

Dave Walen
FAA Aircraft Certification Service
Chief Scientific and Technical Advisor -
Lightning and Electromagnetic Interference
(425) 227-1156 dave.walen@faa.gov

Presentation Topics

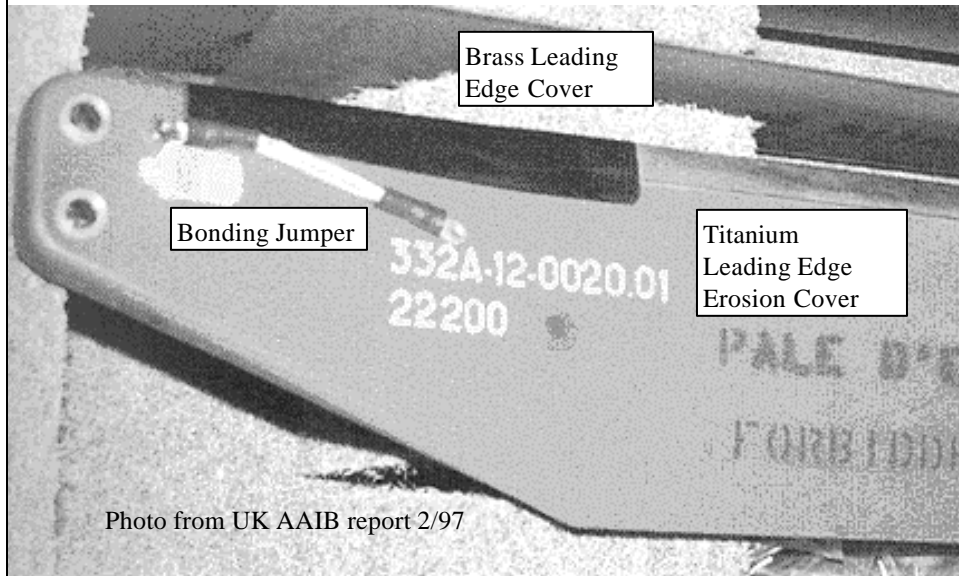
Undamaged Tail Rotor Blade

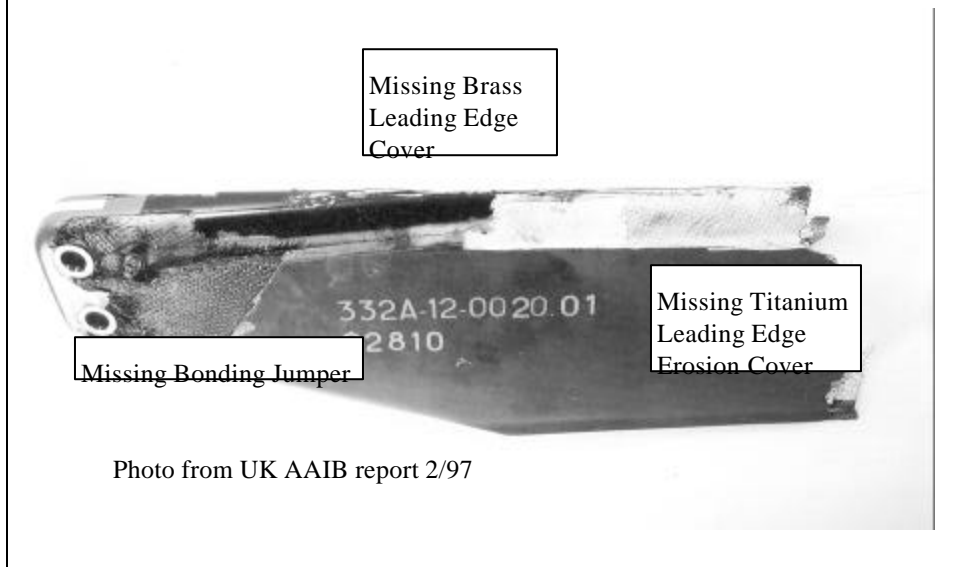
Damaged Tail Rotor Blade

- Damage to tail rotor blade caused unbalance and vibration
- Bolts holding the tail rotor gearbox to tail boom failed, so gearbox separated from the helicopter
- Analysis and test showed that loss of titanium leading edge could cause vibration to failure

- Original AS-332 lightning protection was not tested to today's standard
 - Original lightning protection was qualified to much lower action integral
- Tests using today's standard caused tail rotor blade damage that could result in loss of titanium leading edge
- AD was adopted to require lightning protection improvements

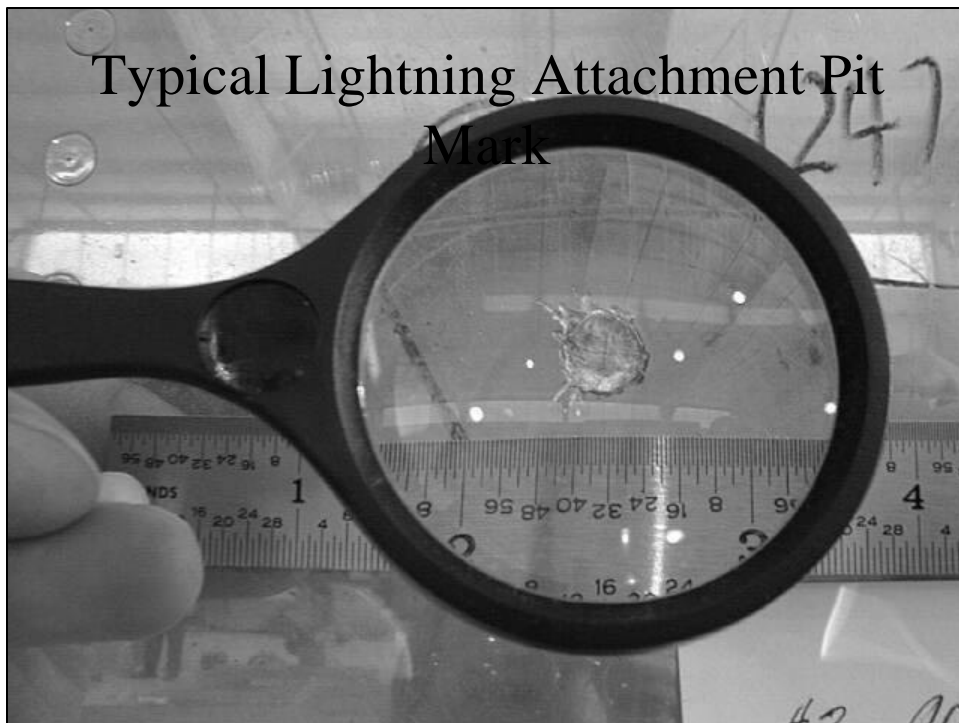
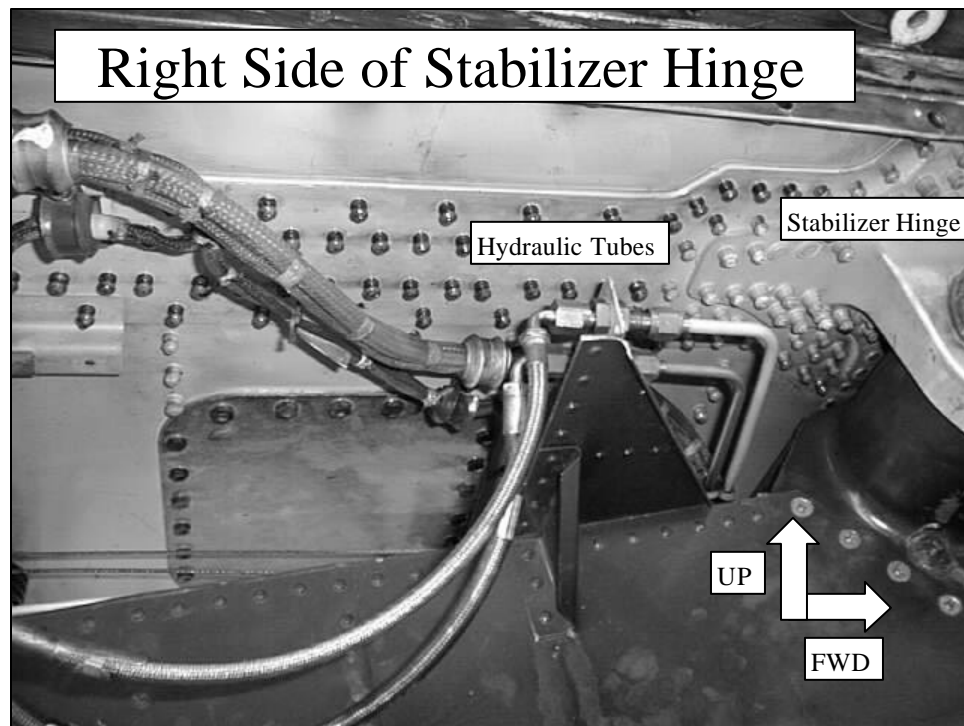
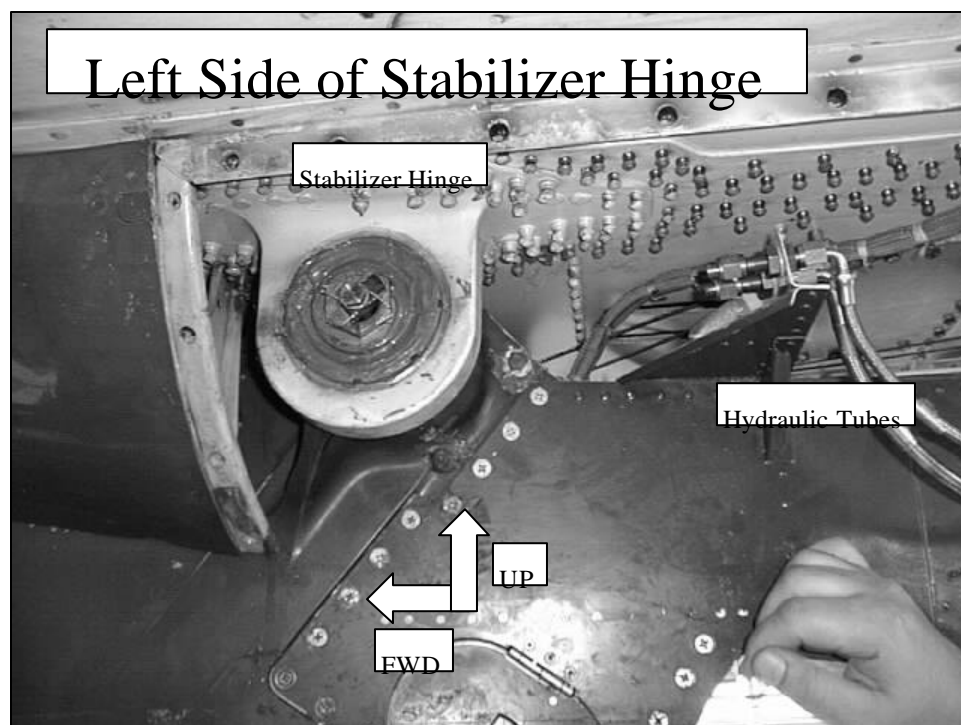
- Lightning attached along lower right side of fuselage and right horizontal stabilizer tip
- Arcing to hydraulic tubes in the horizontal stabilizer hinge area burned holes in two tubes - one from each system
- Loss of both hydraulic systems, and an unrelated brake antiskid failure caused loss of directional control on landing

- Single small-gauge bonding strap carried significant lightning current
- Lightning current fused the bonding strap and arced to adjacent hydraulic tube
- Current on hydraulic tube then arced to adjacent hydraulic tube for second hydraulic system

- Bonding strap was not sized to carry high lightning currents
- Stabilizer hinge and jackscrew cannot be relied on for lightning current path
- Lightning protection must consider the conducted current paths, not just the lightning attachment locations

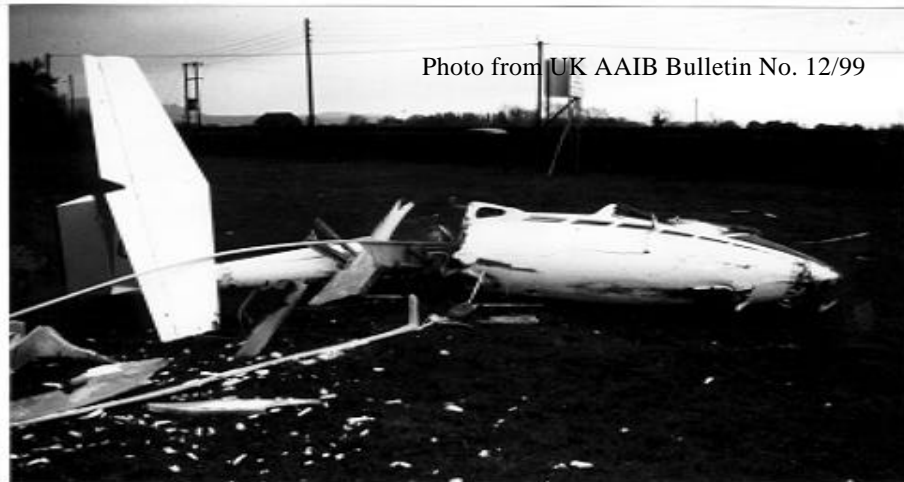
Figure 4

Wreckage of GBP

Cockpit and tail structures were relatively undamaged until impact with the ground

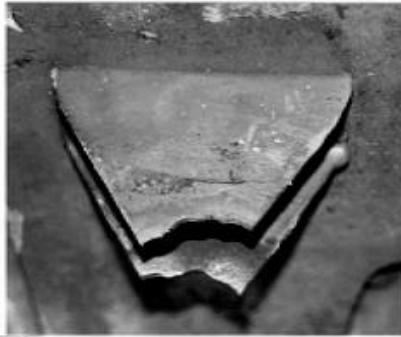
- Lightning attached to both wings
- Explosive arcing in wing and fuselage caused structural failure of wing and fuselage
- Significant lightning arc welding on control rod brackets
- Significant magnetic deformation of control rod tubes

*Right aileron bellcrank mounting bracket
showing melted end and heat effects*

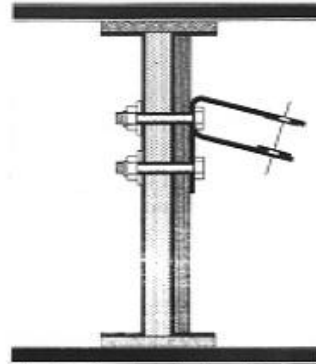
*Sketch of bracket attachment to spar
Two upper bolts, one lower*

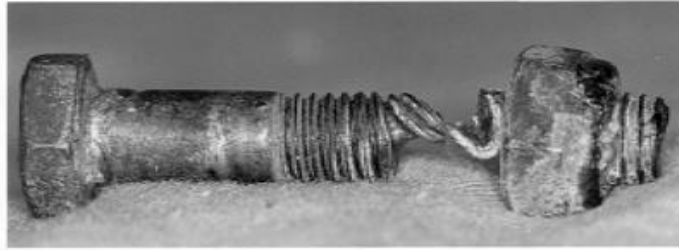
Lower Bolt Failure

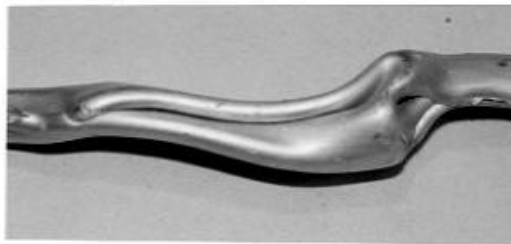
Figure 8

*Details of centre push rod from right wing
Rod is normally a tube of 16mm diameter, 1mm wall thickness*
